Conservation Priorities Based on Current Conditions of Wooden Monasteries in Myanmar

Ei Thandar Kyaw

INOUE, Tomo

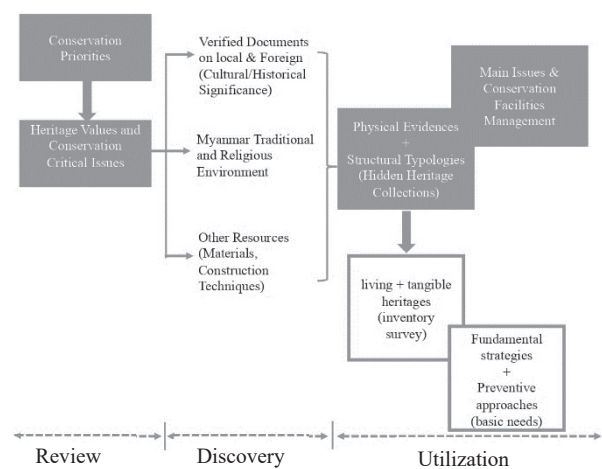
Fig.1.1. Diagram of Research Methodology

According to this diagram 1.1, cultural heritage assets should be followed with providing the wooden monasteries in selected survey data collection in different parts of Myanmar. The analysis underlines the critical approach of inventory plan as foremost with the public, which may serve in a straightforward, honest evaluation for integrating the contrast dimensions of conservation methodology depends on the local current conditions.

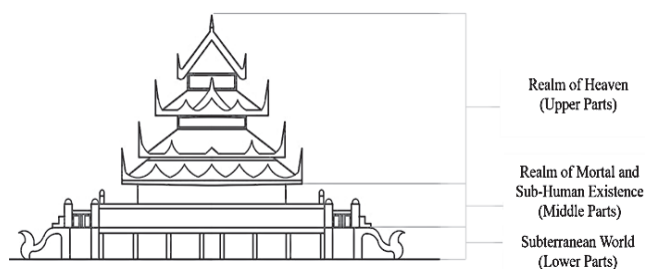
Fig.2.2. General Burmese Monastic Architectural Concept*2

There were four main apartment divisions in a traditional wooden monastery. Generally, it consists of a principal shrine room, an adjoining intermediate area which may serve as a room for the abbot or as a passageway between the shrine and the cavernous main room (including the eastern and western parts), and a smaller apartment at the western end, which usually serves as a store room. The edifice was usually surrounded by a wide veranda where monks perform their daily exercises. To emphasise the hallowed nature of the building, each apartment is marked externally as a set of distinctive multi-storied roofs. Historically, most of the wooden monasteries in Myanmar were only one story high as in form.³ The most important part of the building is located at its symbolic centre - it is a large rectangular hall divided into two square rooms by a partitioning wall.

The room nearest to the eastern entrance is a public space where a Buddha image is displayed and rituals involving both monks and laymen are celebrated. The western room is reserved for activities in which only monks are involved. To the west beyond the main hall, a storeroom is situated that may be attached or unattached to the main structure. The entire structure is visually unified by the continuous horizontal terraces and eaves of the various roofs, as seen in figure 2.3.

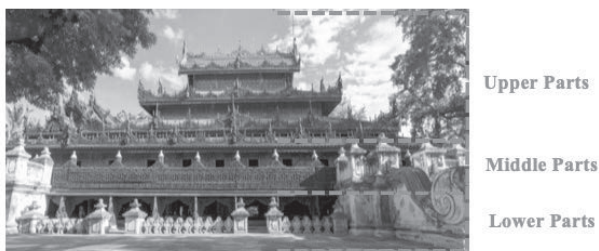
Fig.2.3. Structural Composition of a Monastery ³

Generally, the structural composition of a wooden monastery can be divided into three parts as seen in figure 2.3: (1) the upper parts symbolise the realm of the heavens, including roofing, tiered roofs, sculptures, and traditional roof decorative elements; (2) the middle parts represent the realm of mortal and

sub-human existence, including walls, windows, doors, pillars, and balustrades, and (3) the lower parts characterise the subterranean world, that is, the part below the balustrades, including short supporters, stairs, and the ground decorative elements of a monastery³.

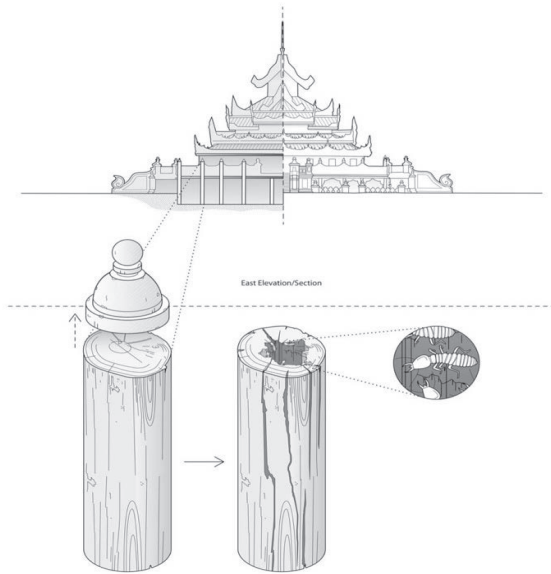
Fig.2.10. Deterioration found on the Termite Issues^{*9}

The teak pillars covered with the marble cap had been damaged by termites - which are white ants that feed mostly on cellulose (wood), as shown in figure 2.10, leading to structural problems and severe rain. Moreover, these teak pillars were directly exposed to the moisture-laden ground due to the weak maintenance of the foundation. The floor adjacent to the veranda has also been damaged by Mandalay's hot and dry weather due to the lack of proper conservation. The Kongbaung era's woodcarving artwork will also be restored to its original state by famous and expert carpenters.

The pillar replacement in this project uses the following replacement techniques; (1) total replacement, (2) partial replacement, and (3) infill replacement. This restoration project aims at the conservation of the monastery and revitalising its surrounding area, in addition to developing a work force com-

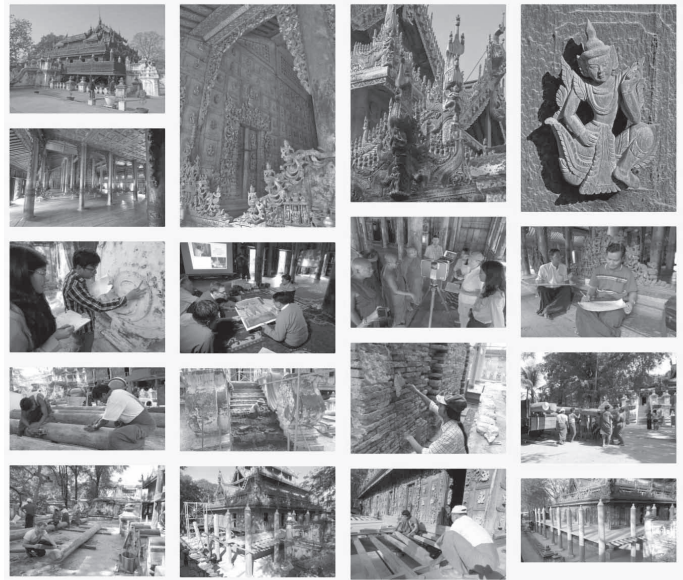
Fig.2.11. Shwe-Nan-Daw Monastery's Restoration Works^{*10}

The prime focus of this project was on restoration; conditional assessment of the pillars that had deteriorated were performed, especially in the south-west parts where the subterranean ornamentation such as the Nayar (Dragon-Serpent) sculptures, as seen figure 2.8 are relatively in the stage of very advanced deterioration, physically weakened, and structurally compromised.

prised of local craftsmen trained on conservation practice and site management skills; including traditional carpentry crafts, traditional timber framing, water damage treatment, and protective measures against fire. This endeavor runs in partnership with local communities and Myanmar's government.⁷

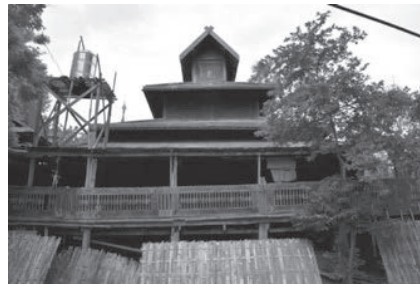
Fig.3.10. Nyaung-U Yoke-Sone Kyaung^{*4}

This monastery dates to the Kon-Baung period. It was refurbished in 1998 and inhabited by the monks where is located in Nayung-U township, Bagan. It is surrounded by the new monastic compound and the original monastery is maintained by the chief monk. There has found out some interventions for original structural enhancement. But the structural condition has deflection on west and south side of this monastery. (See fig 3.9 – 3.11)

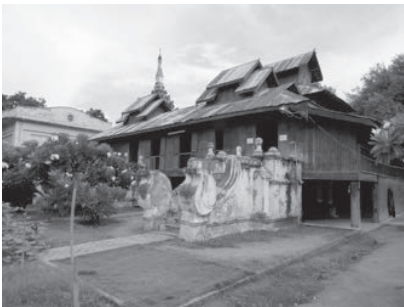
Fig.3.12. Nyaung-U Nat-Daunt Kyaung^{*4}

of local people. It has the characteristics of Kon-baung monastic composition and architectural elements are simple linear composition expressing the traditional Burmese art and architecture. There has also found out some interventions for original structural enhancement. (See fig 3.12 – 3.15)

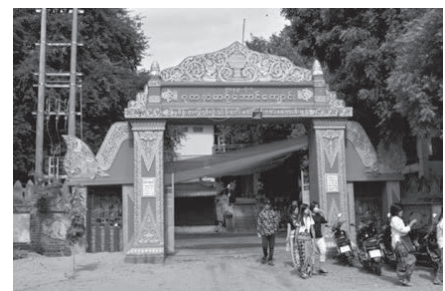
Fig.3.17. New Monastic Compound of Hman Kyaung^{*4}

Hman Kyaung is located within the precincts of the Ananda Temple at Bagan. It was built around 1870 and in 1998, the monastery was in a most perilous state of repair. But after this, the original structure was unfortunately fired in 2017 and now this monastic compound is newly constructed with brick structure monasteries and the remains of the original building cannot be seen in this compound. (See fig 3.16 – 3.17)

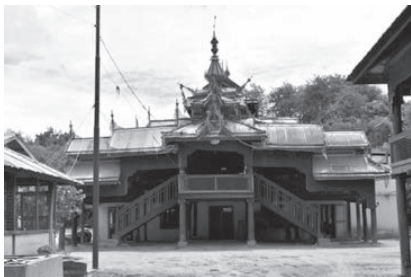
Fig.3.27. Thein Kyaung*⁴

This monastery in Shin-Pin-Sar-Gyo large monastic compound is located about 16km to the south of Sa-Le city. The tradition asserts that the first monastery there was founded in 1338 during the early Ava period and other buildings have been added from time to time. However, the current buildings are dating back from 1858. The compound has also numerous rest houses to accommodate for visiting pilgrims and in the seasonal flooding period, these are like refugee camp for the local people from neighboring villages. This monastic complex can be found pagoda, wooden monasteries, ordination hall and rest shelters for the pilgrims or in case of flood victims from nearby regions. (See fig 3.27 – 3.28)

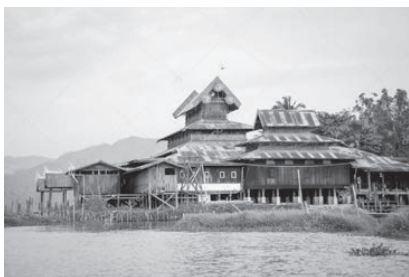
Fig.3.30. Nga-Phe-Chaung Kyaung*⁴

This large spacious Nga-Phe-Chaung Kyaung is also known as jumping cat monastery was built around 1843 from village donations in Ywa-ma, In-Le Lake. The vicinities of this monastery are bordered by the lake and maintained by the local people and the monks. It is necessary to consider the humidity and moisture to the structure because it is constructed in the lake. In Shan states, the monasteries are slightly difference from Burmese culture according to Shan traditional style of their ethnic and regional characteristics. (See fig 3.29 – 3.30)

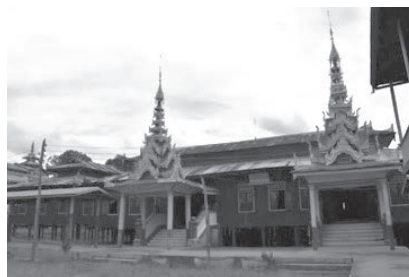
Fig.3.31. Kyaung-Ni Kyaung*⁸

Kyaung-Ni Kyaung is constructed in 1846 and donated with the help of local villagers. In Shan monasteries, the monastic ornamentation is simple and less. It is constructed in the lake and there is necessary for careful conservation approaches for restoration of Shan monasteries. Furthermore, the current condition is regularly maintained by the monks and local villagers but there is less knowledge of conservation plan for the restoration of original structure. (See fig 3.31 – 3.32)

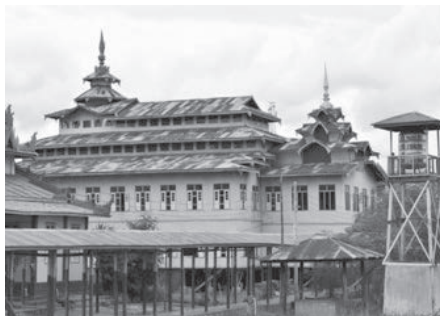
Fig.3.34. Bago Kyaung*4

This edifice Bago Kyaung in In-Le lake has long supported a monastic building built by public donations in 1973. But the monk and the local people maintained the original style of the basic layout remained unchanged. Therefore, this giant wooden two-story monastery is very precious for Shan people and they believe with their ethnic and culture for future persistence. The functional composition of Shan monastery is mainly employed for the main hall especially for the teaching for the novices and spacious expression. (See fig 3.33 – 3.34)

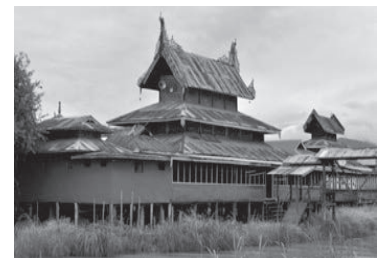
Fig.3.38. Pahtama Taik*4

Also called 'first monastery' located in Ywa-ma village, the special architectural interest is colonial style covered verandahs and telescopic roofing different from other monasteries. The monastery built in 1846 by public donations and there has been occupied by the monks in current conditions. (See fig 3.37 – 3.39)

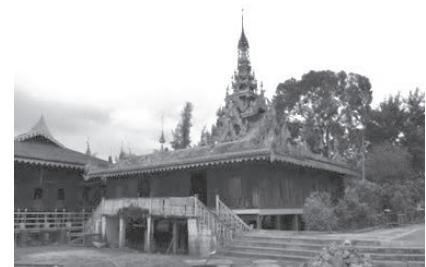
Fig.3.41. Thar-Lay-Taung Kyaung*4

This ancient Thar-Lay-Taung Kyaung is located in In-Le Lake. It was built in 1832. The monastic characteristics is similar to the Konbaung monastic characteristics in central region of Myanmar. The conservation plan has not well developed yet but regularly checked and maintained the deterioration parts of the structure with the help of local villagers and public donations. This monastery is now maintained by the monk (See fig 3.40 – 3.41)

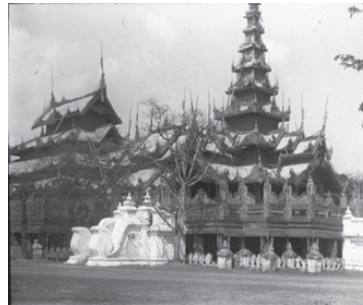
Fig.3.63. Old Photo of Site Plan of Taik-Taw Kyaung*¹³

Taik-Taw Kyaung built in 1857 and one of the famous and largest monasteries donated by the King. But nowadays the whole structure of this monastery had been already disappeared and only four brick staircases where can see in yellow circle area of figure 3.36 are remained in its original location maintained by the local monks. (See fig 3.62 – 3.64)

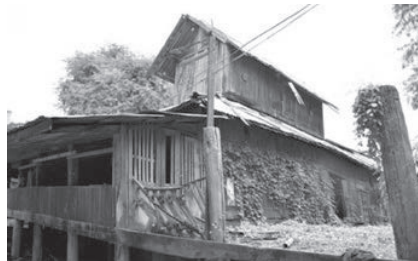
Fig.3.75. Deterioration of Thin-Gaza Kyaung*⁵

Thin-Gaza Kyaung is also one of the famous monastic spired roofing styles located in the Deiwun quarter of Mandalay. It was built in 1861. It is currently used as a monastery and accommodated. However, the structural composition is very vulnerable because of larger and spacious structure with many rooms are very in a perilous state without proper maintenance. In the western end of this monastery is very deflection into one direction and ruined parts need extensive repairs. (See fig 3.77 – 3.79)

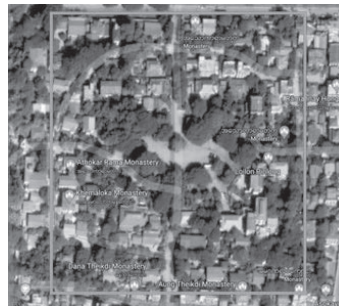
Fig.3.98. Current Existing Site Plan of Ashoka-Yama-Taik^{*5}

Ashoka-Yama-Taik also called Yadana-Bon-Kyaw Kyaung constructed during 1787-1790 with massive monastery type in this era and it is still located in its original location. There can be seen the remaining 10 brick staircase and maintained as the original ruins of these staircases by the monks without any reconstruction. (See fig 3.97 – 3.99)

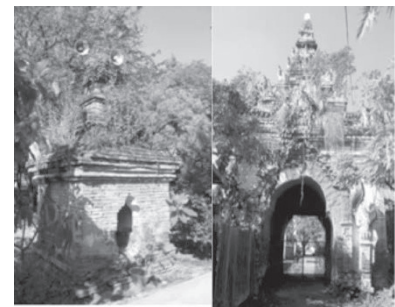
Fig.3.104. Existing Brick Gate of Medaw Kyaung: Queen Mother’s Monastery^{*5}

The Queen Mother’s monastery which was one of the impressive wooden monasteries, built in 1842 donated by the King’s step-mother. The monastery was known for its immense beauty which won the attention, admiration and attribution of Myanmar traditional art and craft advancement. Unfortunately, it was bombed during the second world war and now it can only see the existing great walls of entrance brick gate of this monastery and other parts were already burnt out by the fire. (See fig 3.102 – 3.104)

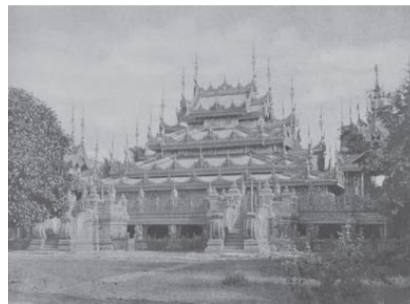
Fig.3.106. Old Photo Record of Thameedaw Kyaung: The Princess Monastery*13

The Princess monastery built in 1842 and adorned one of the finest wooden monasteries of Burma. Around the original location of its monastery, it has newly constructed by modern monastery and Nun school as the interventions. Therefore, the existing entrance walls and brick staircases are remained. (See fig 3.105 – 3.106)

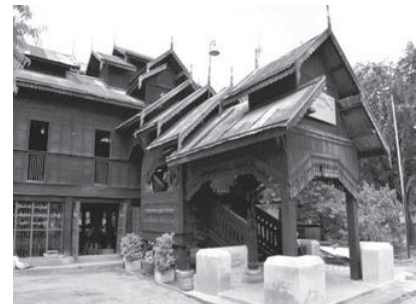
Fig.3.107. Pyi-Min-Thar Kyaung*5

Traces of the original wood-carving are still evident along the badly weathered balustrade and the well preserved previously. In 1988, the monastery was repaired especially the verandah and maintained under the Mandalay Department of Archaeology. (See fig 3.107 – 3.108)

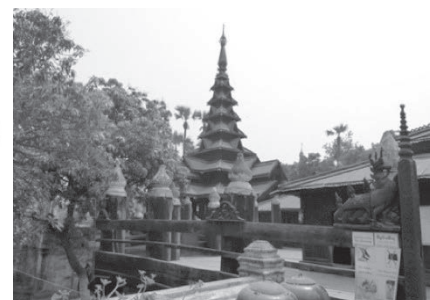
Fig.3.110. Bagaya Kyaung (Innwa)*5

Bagaya monastery was founded during the reign of King Min Hkaung (1401-1422) in Ava dynasty. It was rebuilt in 1698 by the King Min-Ye-Kyaw-Htin. It is ornamentally simple and very authentic Ava monastery. Then, it was refurbished again in 1991 by the Mandalay Archaeology Department and restored as the museum of functional adaptive reuse. (See fig 3.109 – 3.112)

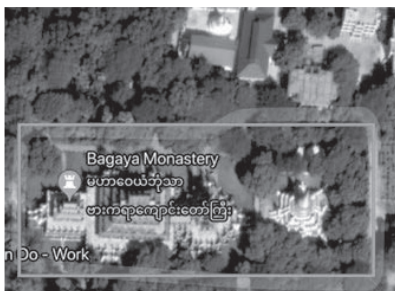
Fig.3.119. Current Existing Site Plan of Bagaya Kyaung*¹²

The original structure of Amarapura Bagaya Kyaung was constructed in 1782-83 by King Bo-Daw-Hpaya located in Amarapura. This monastery was fired in two times; one in 1821 and again in 1866. Therefore, this new structure of Amarapura Bagaya monastery was completely rebuilt again with using reinforced concrete for the whole building and now it is not used by the monks as the function of the monastery. It is preserved in the adaptive reuse as the museum for public pilgrims. (See fig 3.119 – 3.121)

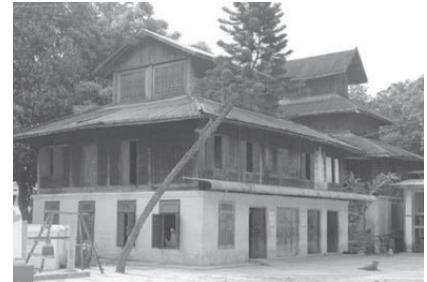
Fig.3.124. Bo-Daw Kyaung^{*5}

This monastery was donated by Saopha (Shan Kingdom) in 1891 at Pangthein-Taung quarter of Hsipaw. The main monastery building is splendid but only the skeleton structure remained and the wall is repaired with brick. It is maintained by the local villagers. (See fig 3.122 – 3.124)

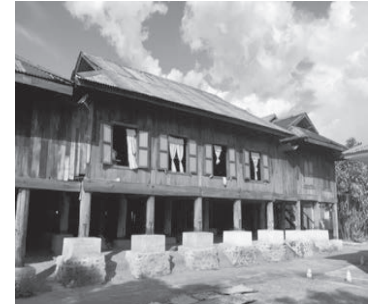
Fig.3.130. Maddayar-Shwe Kyaung^{*5}

Maddayar-Shwe Kyaung is also the ancient monastery in Hsipaw and the interview with the older people, this was also donated by Saopha (Shan Kingdom). This monastery was built in 1863 located in the new village of Hsipaw. In current, it is maintained by the chief monk and local people. The structural conditions of this monastery is in good conditions and it should be regularly maintained and checked with proper maintenance plan. (See fig 3.128 – 3.130)

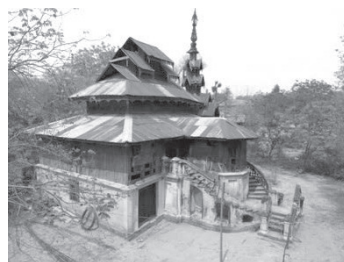
Fig.3.138. Sagumaw Kyaung^{*5}

Sagumaw Kyaung is located in Monywa, Le-zin village and built in 1936 in the late colonial period. The structural condition of this monastery is very weak in current conditions and it may be no longer existed for 4 or 5 years if the conservation management plan would not be considered for it.

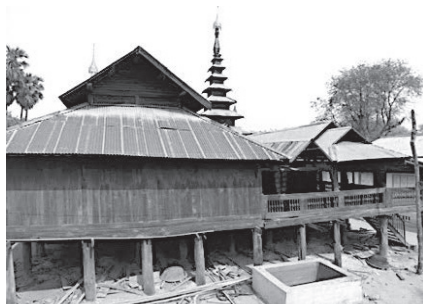
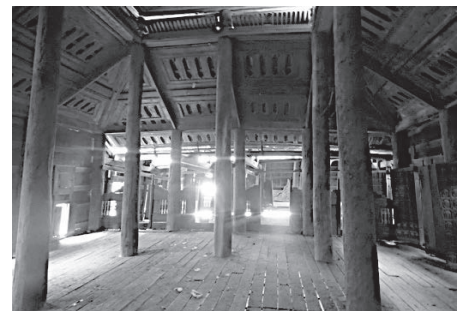
Fig.3.141. Taing-Tayar Kyaung^{*5}

Taing-Tayar Kyaung is located in Monywa, Le-zin village and constructed in 1896 using local carpenters, masons, blacksmiths and goldsmiths. The monastery is famous for its architectural esthetics of the seven-tiered pythat roofing and it has not been occupied since the mid-1960s and the structural condition is very vulnerable especially in the connection of the roof, interior of the flooring and other elements. (See fig 3.140 – 3.142)

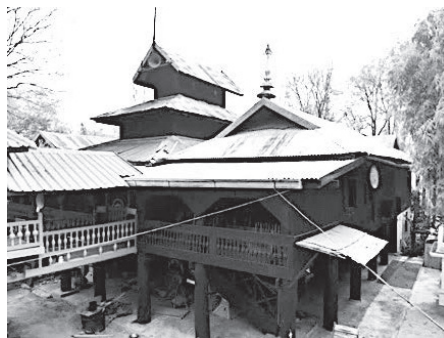
Fig.3.144. Mahar-Zawtika-Yama Taik^{*5}

composition in a larger complex of monastic buildings. This has been found that some intervention in the additions of new paintings and the modern elements such as installation electronic equipment which may be dangerous in case of fire. (See fig 3.143 – 3.144)

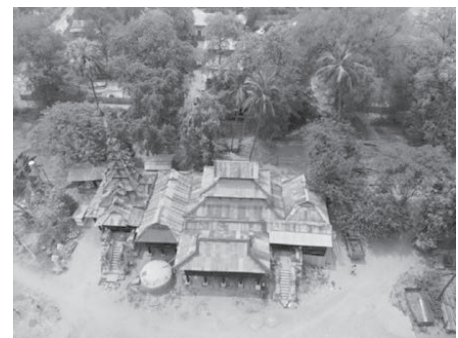
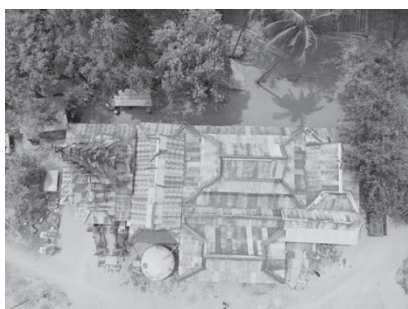
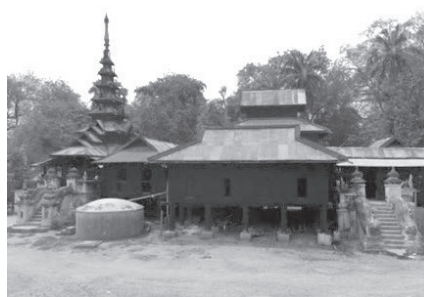
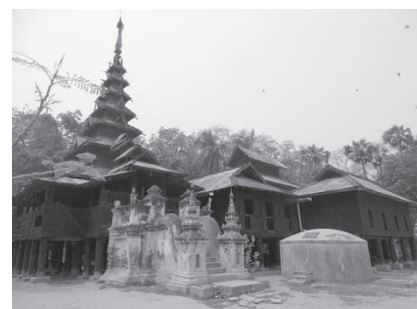
Min-Ye Kyaung is located in A-Myint village which is far 28km from Monywa district. This monastery was donated by the King Swar-Saw-Ke in 1375 over 644 years old wooden building. This very old monastery maintained by the monks that has been found that refurbished many times and the original of staircases and the roofing parts are the characteristics of Innwa era. (See fig 3.145 – 3.148)

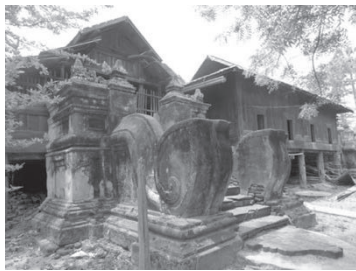
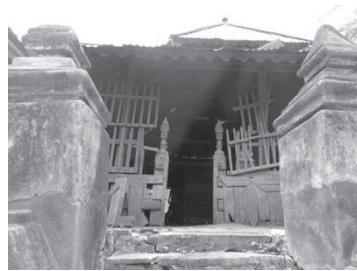
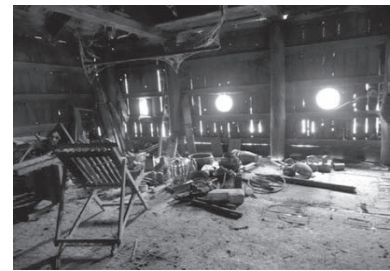
The structural condition is deteriorated by neglect or old age of the monastery. But in this compound, there has other new monasteries and the original main monastery should be preserved very systematically for such this of linear composition of Kon-baung wooden monastery and this edifice is very rare to find in that area too. Now it is looked after by the local monks. (See fig 3.149 – 3.151)

Fig.3.150. Ruins of Bon-Pyan Kyaung*5

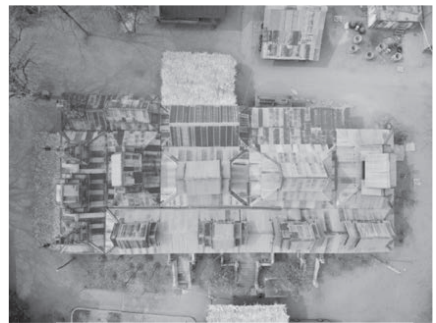
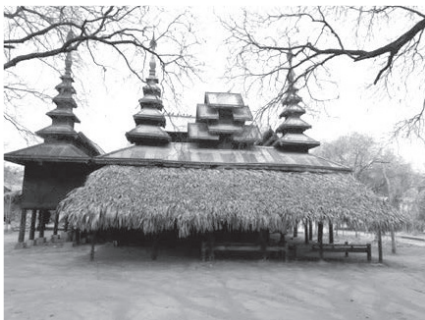
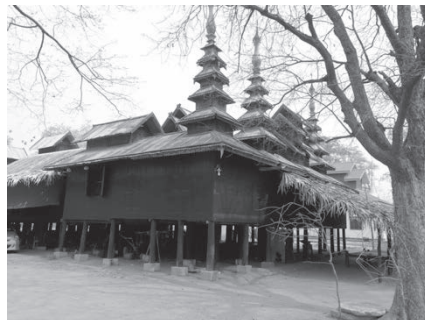
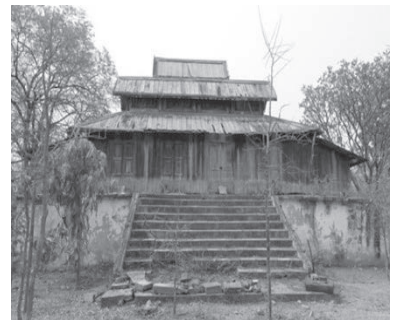
This quiet and old monastic compound is located in Pakkoku, Myaing township. The monastery was donated by the King in late Bagan period. There has two wooden monasteries; the building 1 is well maintained and reside in it. However, the building 2 is vacant condition and some parts are previously ruined such as the brick staircase and some wooden pillar deterioration. Moreover, it is protected under the ministry of religious affairs and culture. (See fig 3.163 – 3.166)

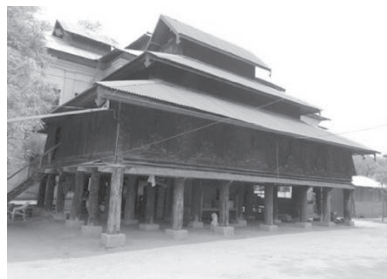
Fig.3.168. Ohn-Don-Bin-Shwe Kyaung*⁵

Ohn-Don-Bin-Shwe Kyaung is one of the good examples of wooden monasteries from Myanmar. Originally it was one of fifteen apartments given by various donors which comprised the impressive Marorama Kyaung Taik (Monastery group). It built in 1738 and the only remaining apartment nowadays and probably the earliest surviving Burmese wooden monastic building in existence maintained by the Department of Archaeology with the help of chief monk and the local villagers. (See fig 3.167 – 3.170)

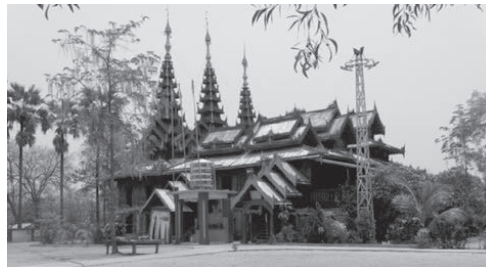
Fig.3.171. Atula-Mingalar-Thiri Kyaung*⁵

uated in Pauk township, Magway division and also old monastic features over 100 years old. But some parts especially in the facades have found new intervention with modern color and materials using in the original structure of main building. (See fig 3.171 – 3.172)

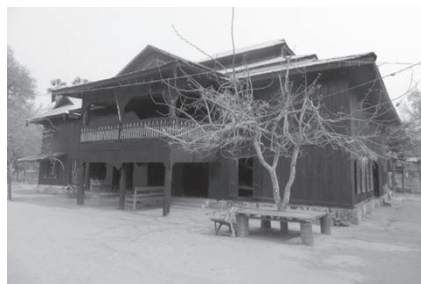
Fig.3.173. Khan-Taw-Taung Kyaung*⁵

Khan-Taw-Taung Kyaung also called Bagan monastery, located in Pakkoku. The construction period of this monastery is probably in the early 19th century according to the interview with the chief monk. In this monastery, there has also the historical documents of inscriptions. But the monastery is often suffered by the seasonal flood every 3 or 4 years in rainy season. (See fig 3.173 – 3.175)

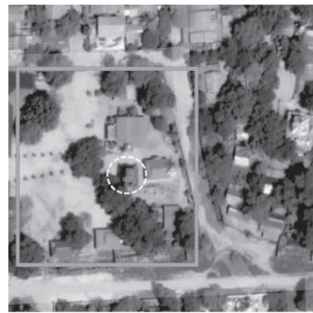
Fig.3.177. Current Existing Site Plan of A-Neint Kyaung*¹²

The former 19th C A-Neint Kyaung wooden monastery located in south-west of Pakkoku. It succumbed to fire in 1989 and there are no plans to rebuild the monastery. Currently in that area, the remains of masonry library occupying in the north-east corner in the current existing site plan of yellow circle area. (See fig 3.176 – 3.178)

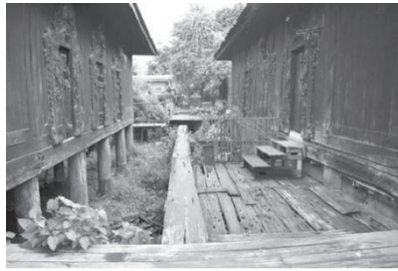
Fig.4.5. Western Part's Passageway Flooring of Thin-gaza Monastery*4

In cases of structural weakening, the monastic features are still present and it is possible to immediately restore structural stability. However, the whole could be partially restored at the points of structural failure. As seen in figures 4.4 and 4.5, some parts of structurally weakened monasteries have become fragile enough to collapse easily. If such structures are not conserved they could turn into debris, in which case it may be difficult to restore the original fabric. Thus, conservative intervention can help prolong the existence of old heritage.
